Rapid Damage Assessment Exercise

RAPID DAMAGE ASSESSMENT EXERCISE

Address: 11 RIVER ROAD, YORKTON

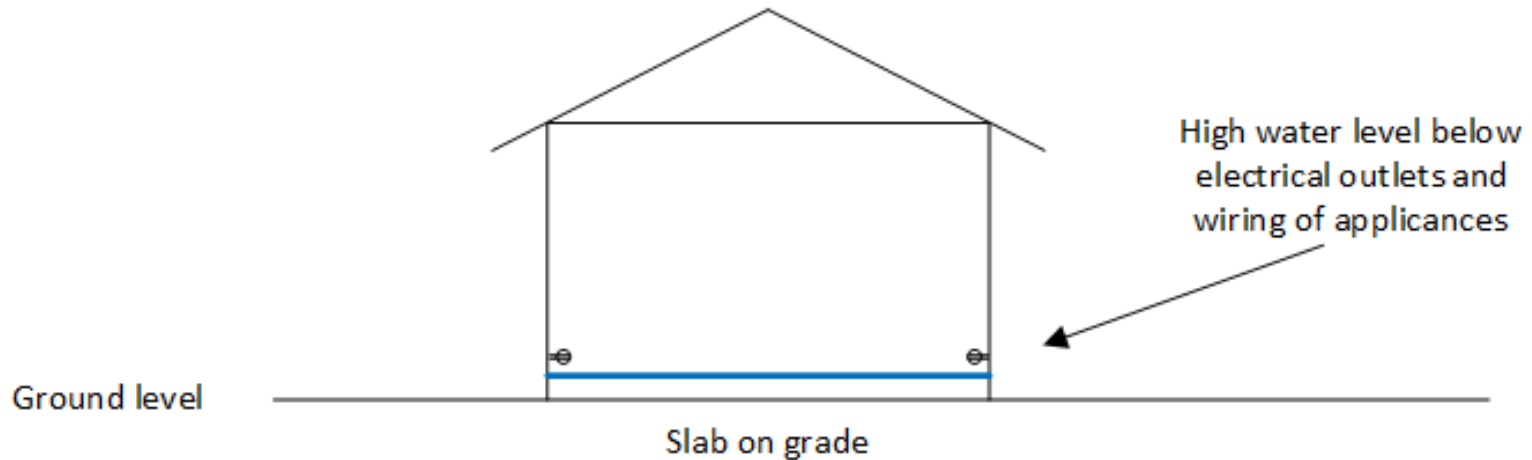
Flooding “Minor – None” rating **INSPECTED**

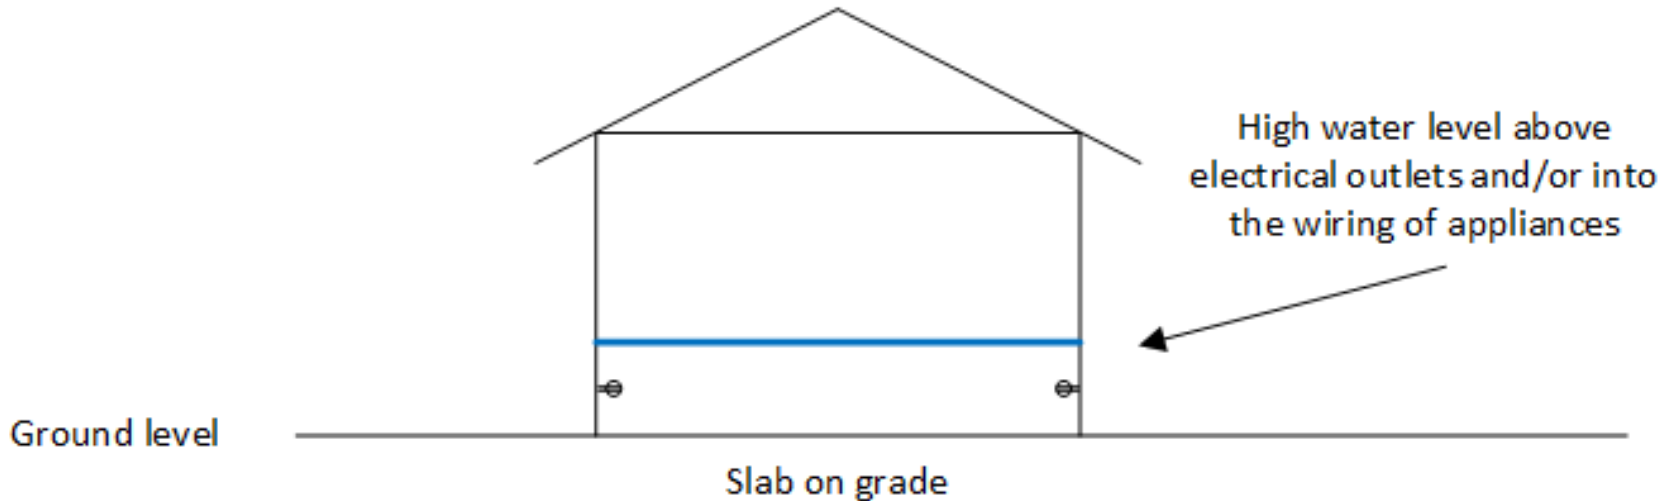
Flooding - “Moderate” rating **RESTRICTED USE**

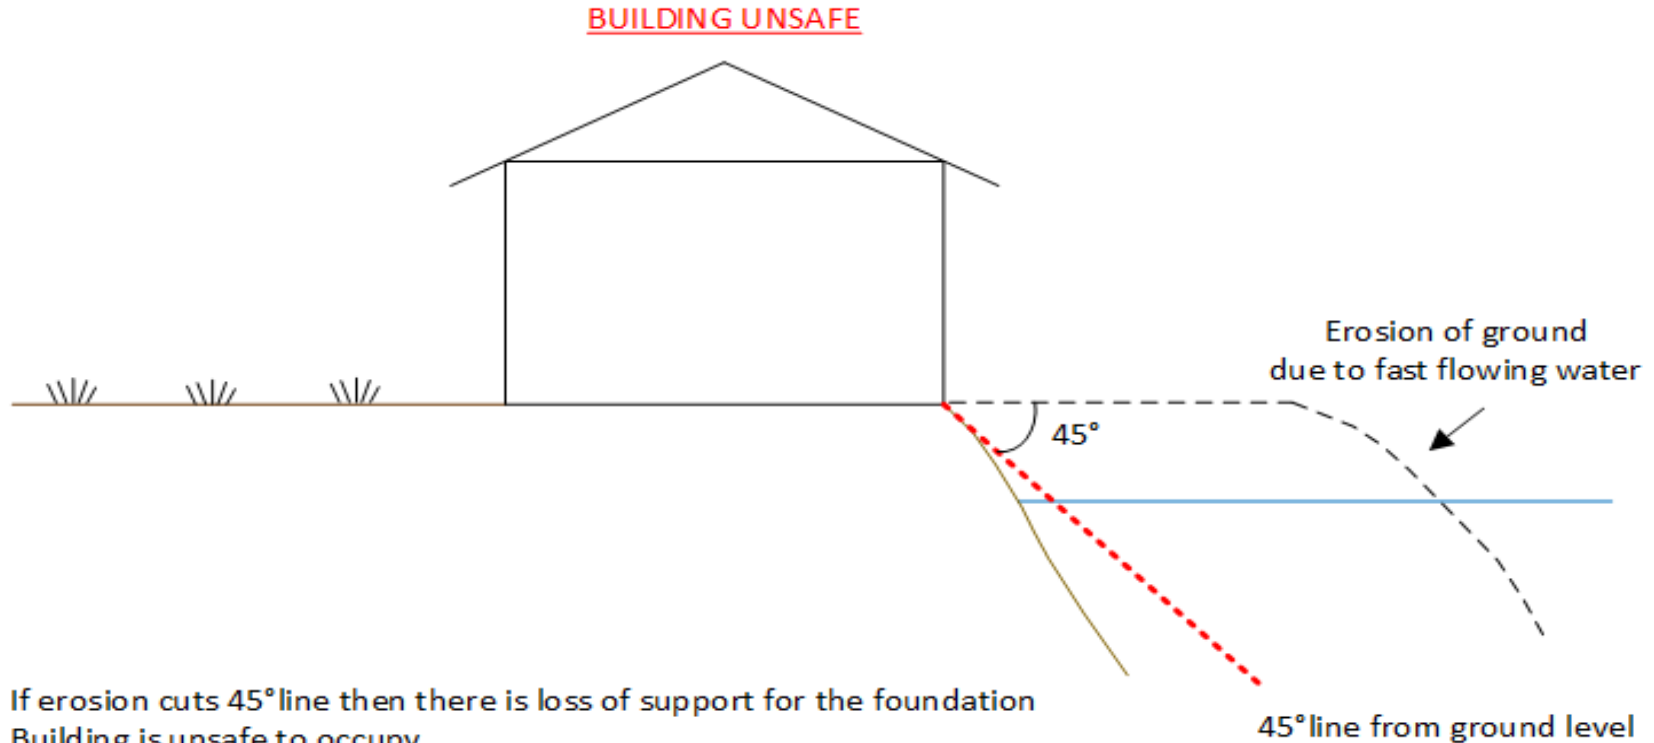
If building ground floor is level – Geotechnical evaluation required
If building is leaning – structural plus geotechnical evaluation required

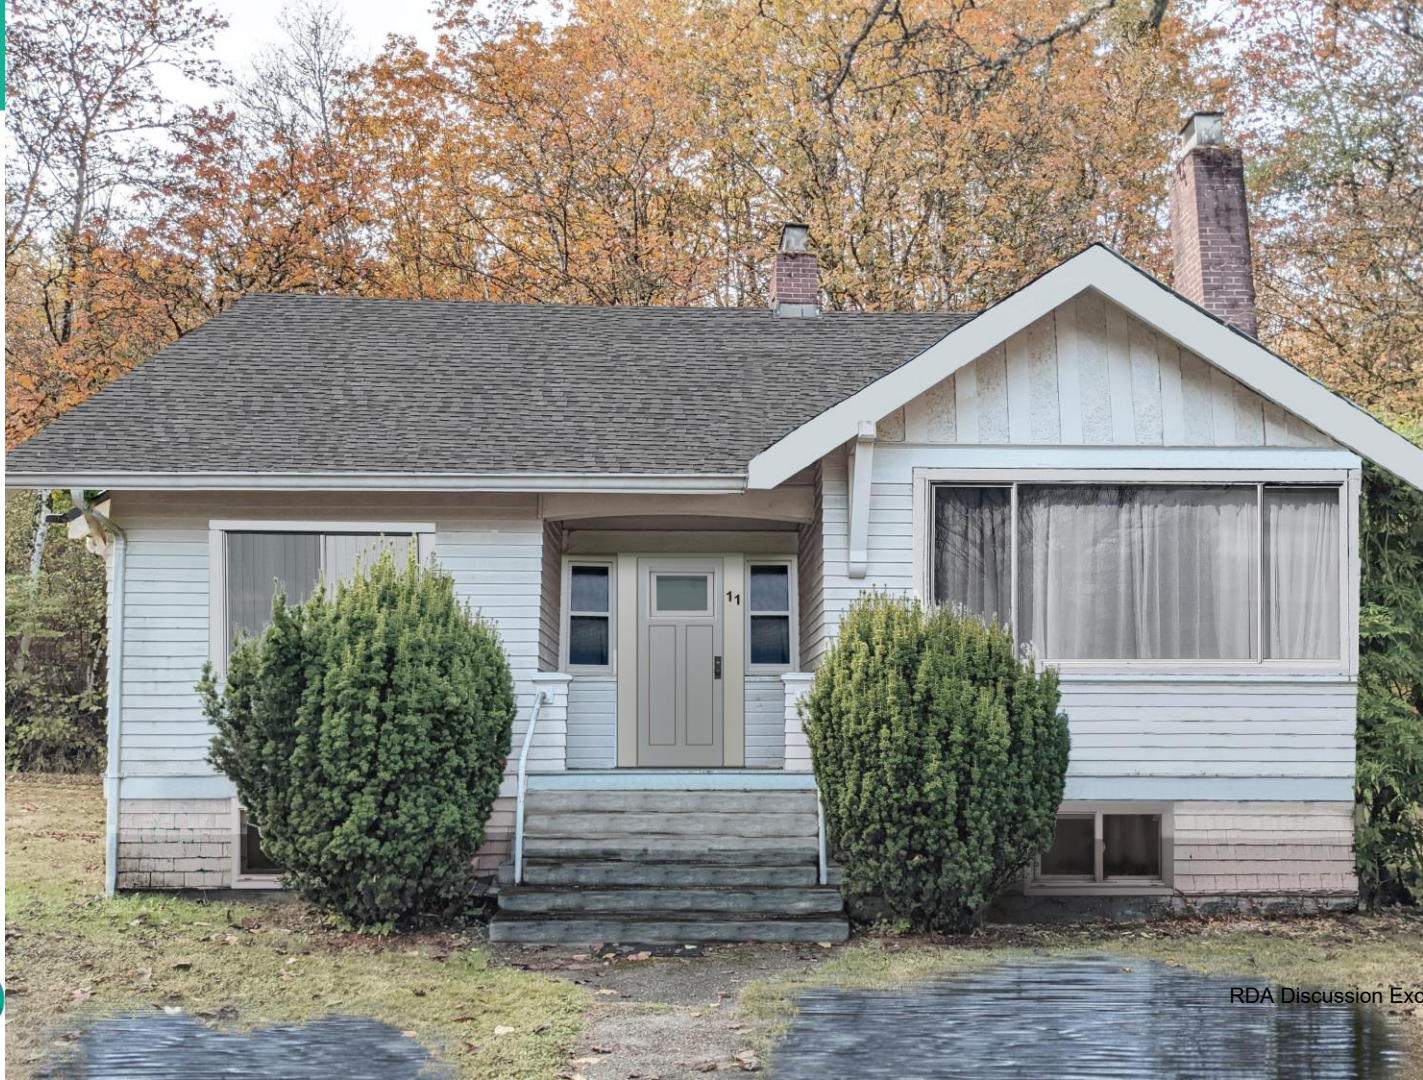
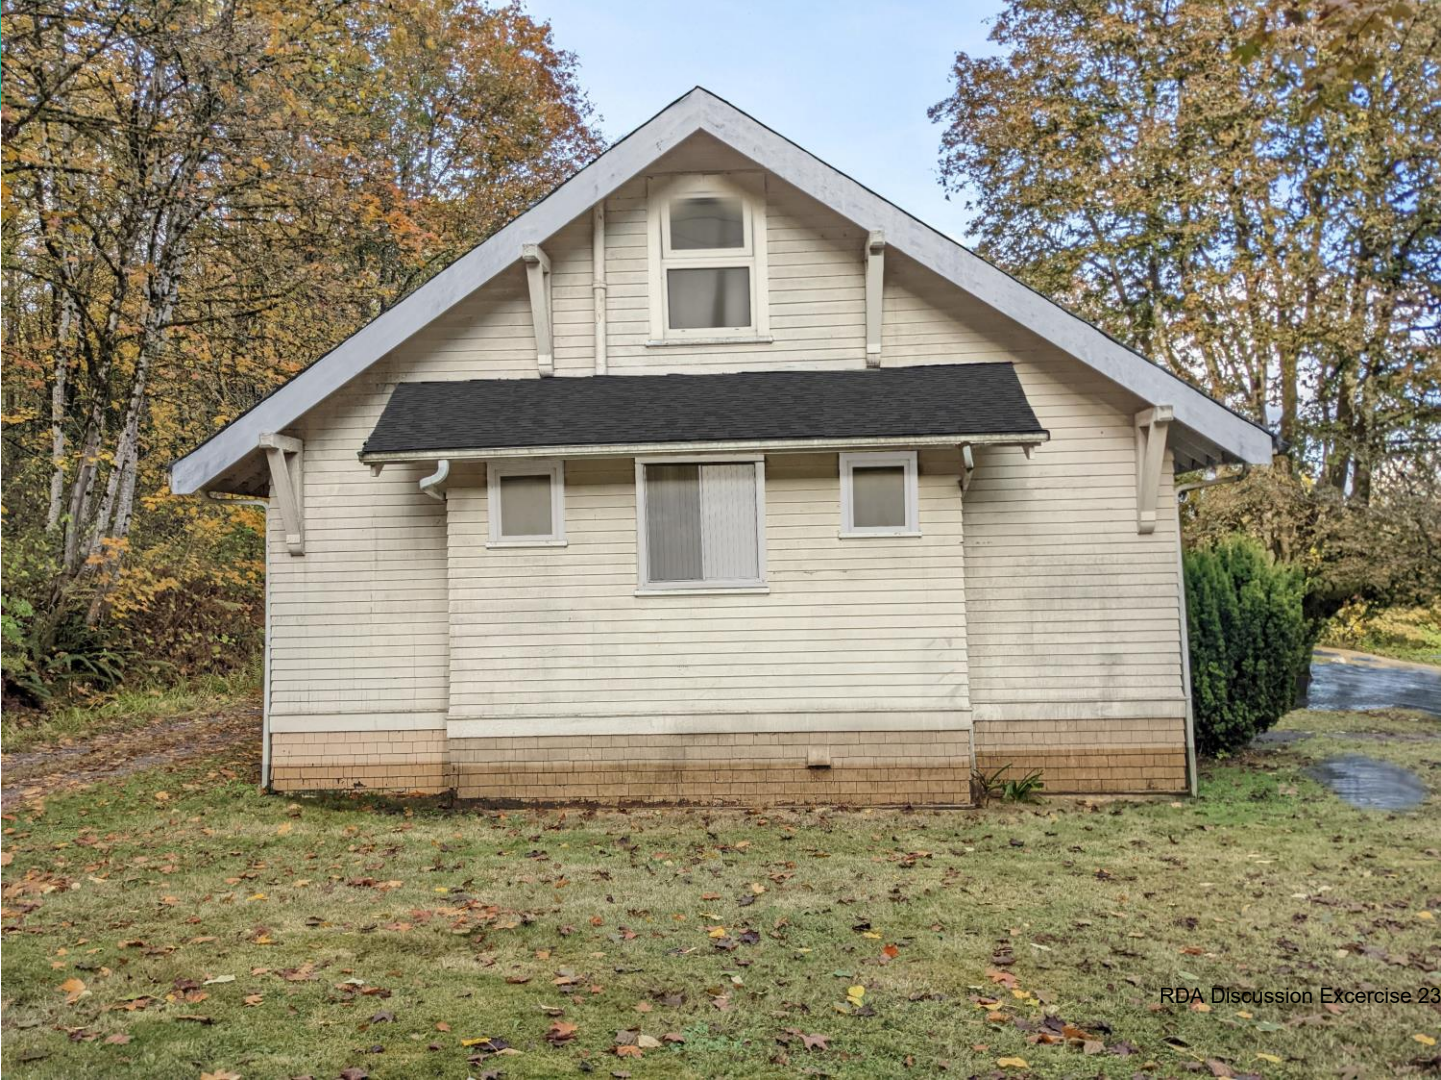
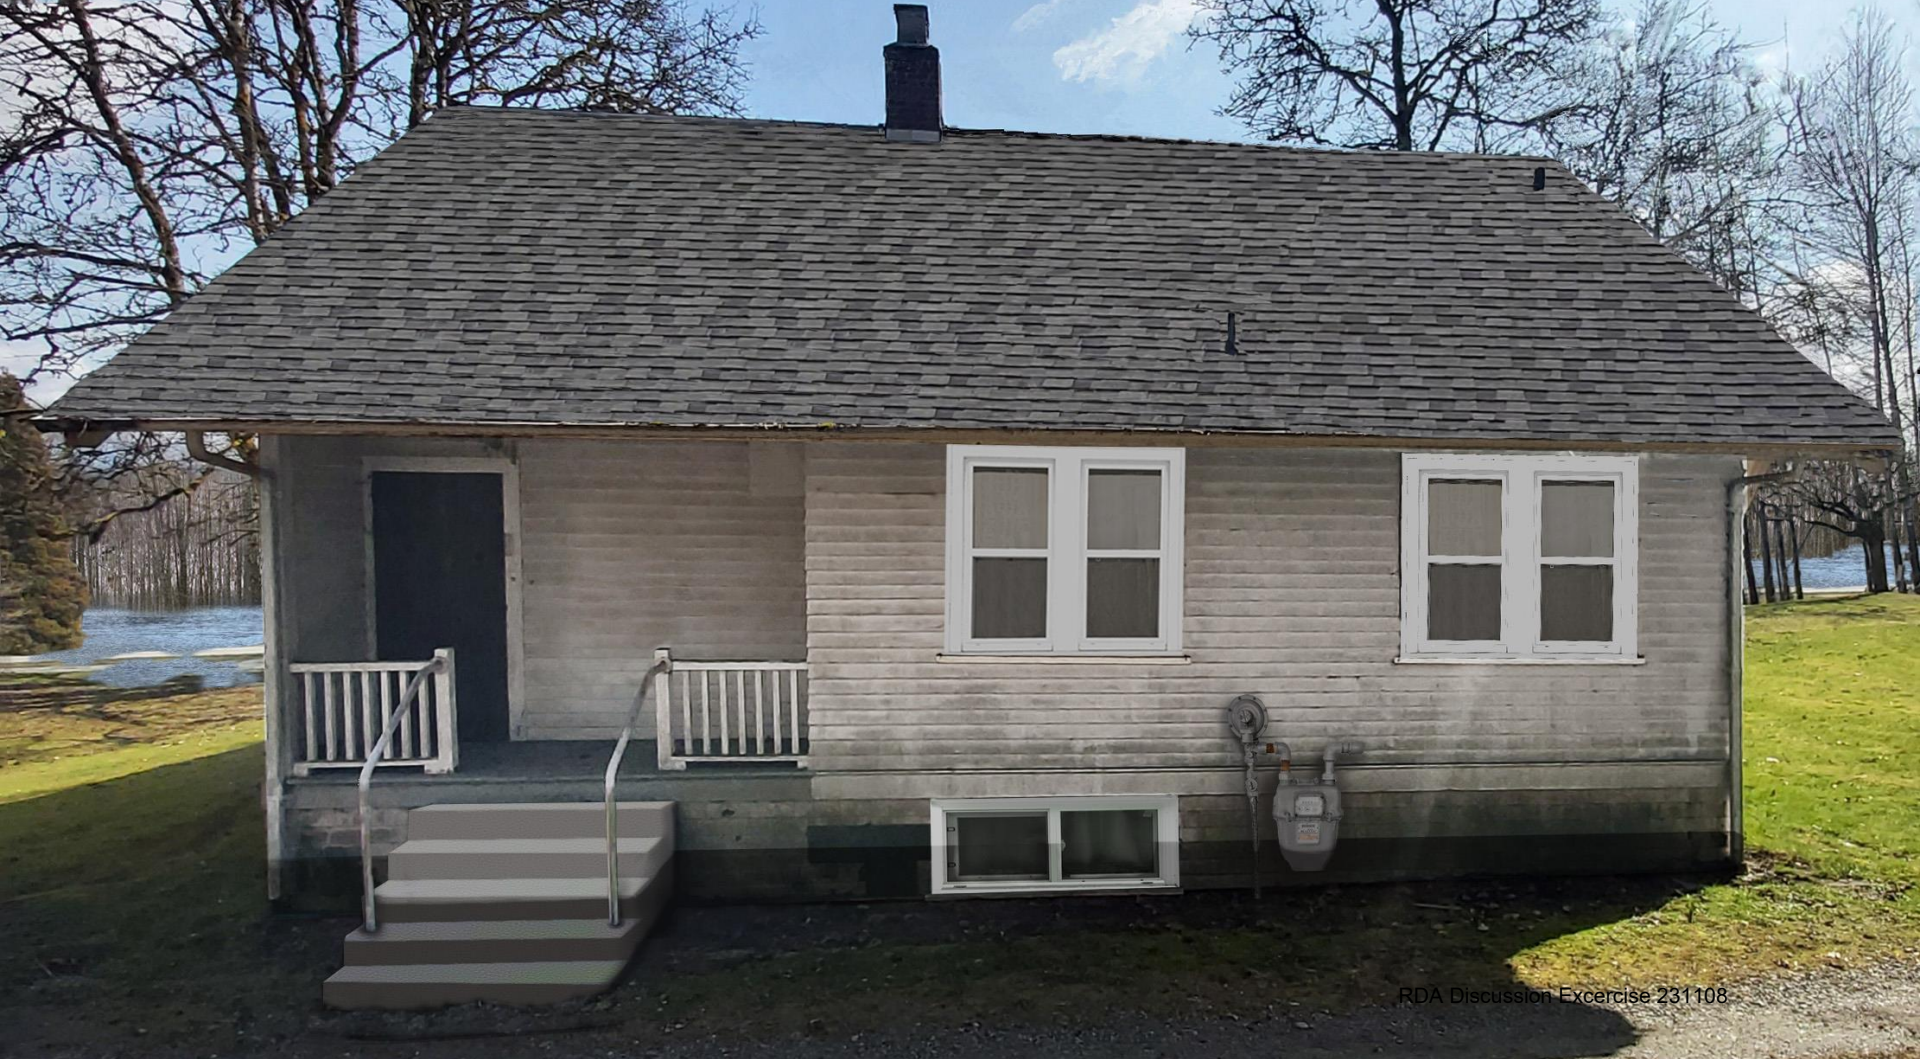
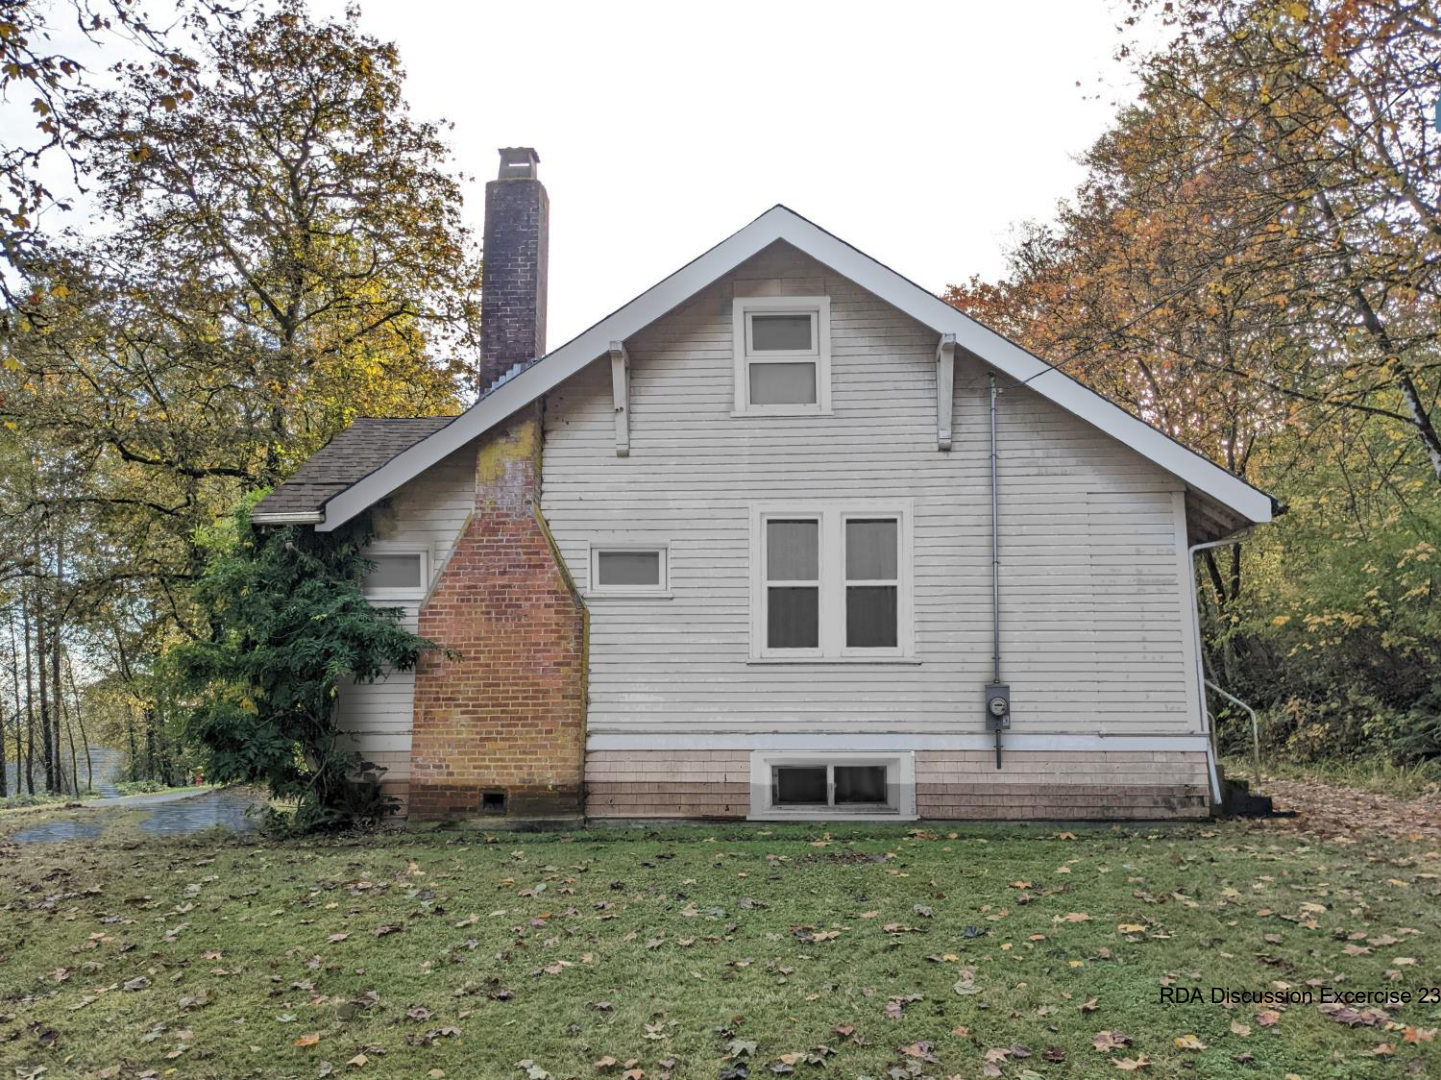
There are 4 photos (one per side) of a building on River Road.

Comments: WATER HAS FLOODED INTO THE BASEMENT VIA THE BASEMENT WINDOWS
HIGH WATER MARK - 0.3 METRES BELOW GROUND FLOOR

CAUTION: This structure has been inspected for life safety purposes only and found to be damaged as described below: WATER HAS FLOODED INTO THE BASEMENT VIA THE

BASEMENT WINDOWS

HIGH WATER MARK - 0.3 METRES BELOW GROUND FLOOR

Do not enter or use the following areas: **BASEMENT UNTIL WATER DRAINS OR IS PUMPED OUT**

Do not use flooded/damaged appliances, devices or services (**electric, gas**) until recertified by a licensed contractor

Comments: ELECTRIC POWER AND GAS SUPPLY IS OFF AT HOUSE
